Docket No. 217 – Development and Management Plan Inspection

Northeast Utilities Service Company Certificate of Environmental Compatibility and Public Need for the construction of a 345-kV electric transmission line and reconstruction of an existing 115-kV electric transmission line between Connecticut Light and Power Company's Plumtree Substation in Bethel, through the towns of Redding, Weston, and Wilton, and to the Norwalk Substation in Norwalk, Connecticut.

Date: August 30, 2006

Location: 115 kV Underground Route

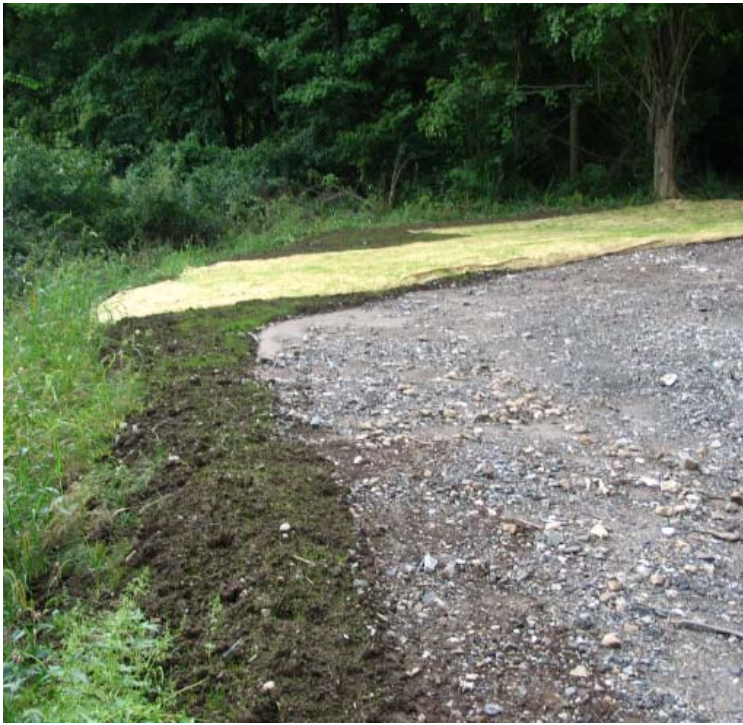
Photo on the left shows the repaired area at the Bethel Ed Park near the south tower. A new section of erosion control matting was installed and the area was seeded. Photo on the right shows a close up of the washout which has since been repaired. Silt fence was restored. 8/30/06

Areas of Inspection	Observation	Recommended Action	Corrective Action
Active Work	<p>- Bethel Educational Park: - Erosion control mats were extended and the washout was repaired. 8/30/06</p> <p>-No other work was noted at this time. 8/30/06</p>	<p>-Silt fence was repaired and the area was loamed and seeded. 8/30/06</p> <p>- None at this time. 8/30/06</p>	<p>The area was repaired and stabilized</p> <p>N/A</p>
Erosion and Sediment Controls Bethel Education Park	- The washout at the slope of the BEP south tower was repaired and the adjacent area loamed. Silt fence was repaired and an erosion control mat was installed. 8/30/06	-The area was repaired and stabilized. Continue to monitor for final re-vegetation. 8/30/06	The area was repaired and stabilized
Route 58	-At Hoyts Hill transition structure, the restored area continues to show grass growth 8/30/06	- Continue to monitor for final stabilization. 8/30/06	N/A

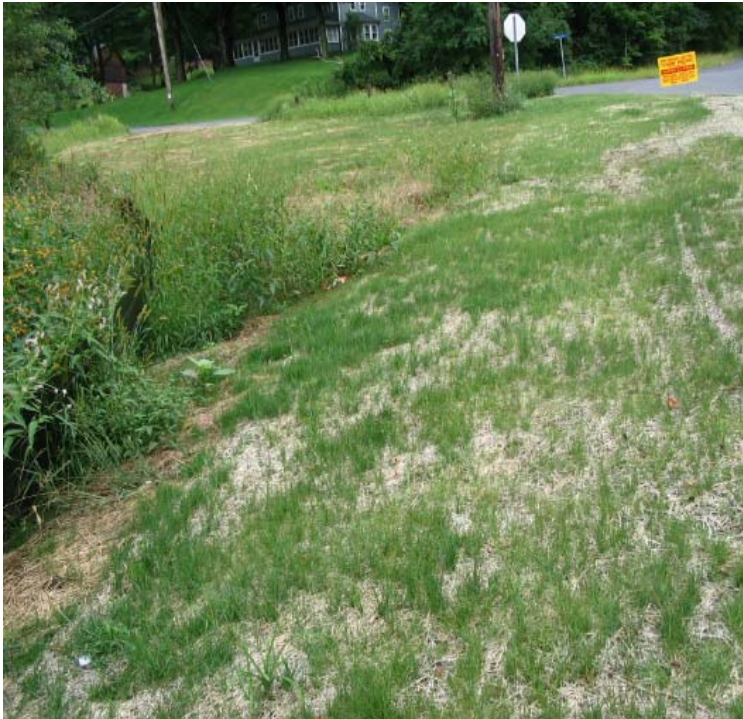
Photo on the left shows grass growing well along the matting installed at the Sunset Hill Rd area. Photo on the right shows grass growth returning along the recently restored driveway across from Hoyts Hill off Rt 58. 8/30/06

- At Sunset Hill Rd. vegetative growth continues at the mats. 8/30/06	- The entire area is now well restored. Continue to monitor. 8/30/06	N/A
Rt. 107 (Lonetown Rd)	- The Redding CC storage area stone surface remains stable and controls are in good shape. 8/30/06	- None at this time. Evaluate final restoration measures for this area. 6/1-8/30/06	Restore when feasible
